## SITE (47) MILLPOOL COLLIERY POOL

#### 9.21 Mill Fields Pool

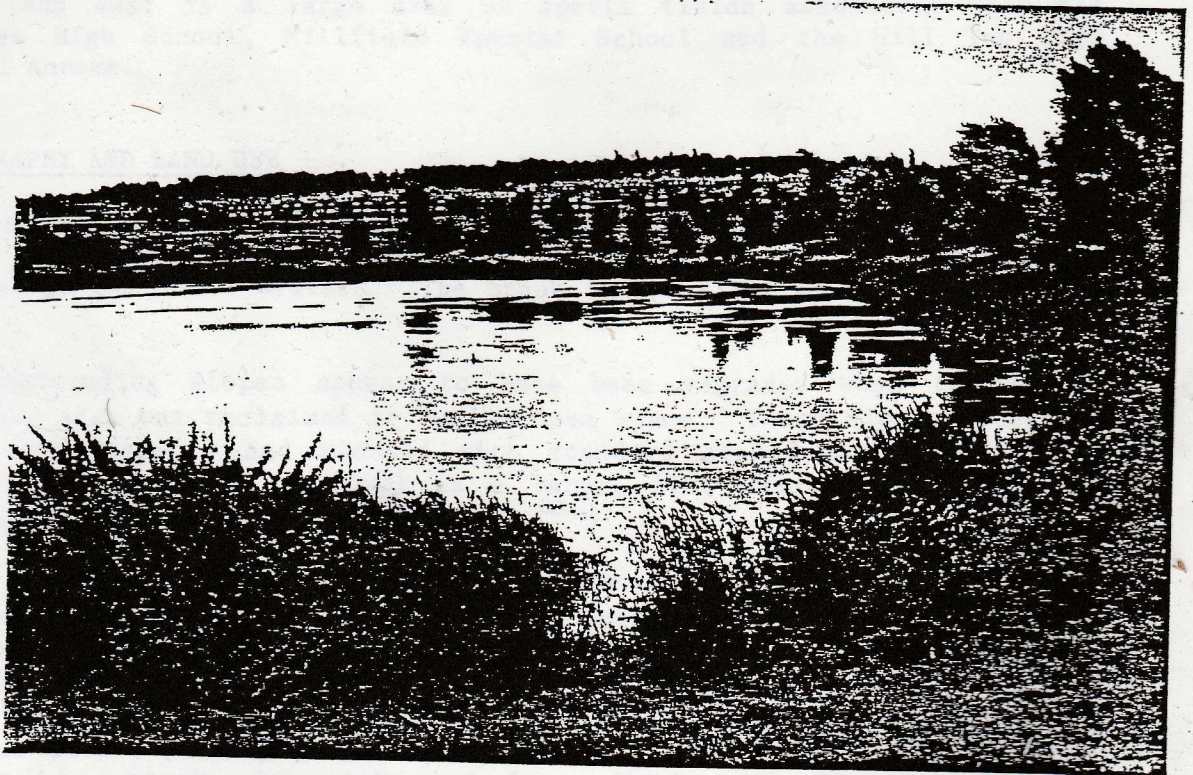
This is an excellent feature of some 1500 square metres with a deep border of reed, nettle and bull rush. There is also considerable plant growth on the surface. There are no islands and the perimeter path is well back from the water edge fringe. The outlet is grilled but the inlet pipe on the far side of the pool is wide open!

9.21 MILL FIELDS POOL, more excellent edge treatment

The distant outlet pipe should be grilled to prevent inviting access.
