Gower Tip, Tividale

Non Technical Summary

14 September 2021

Project No.: 0509665

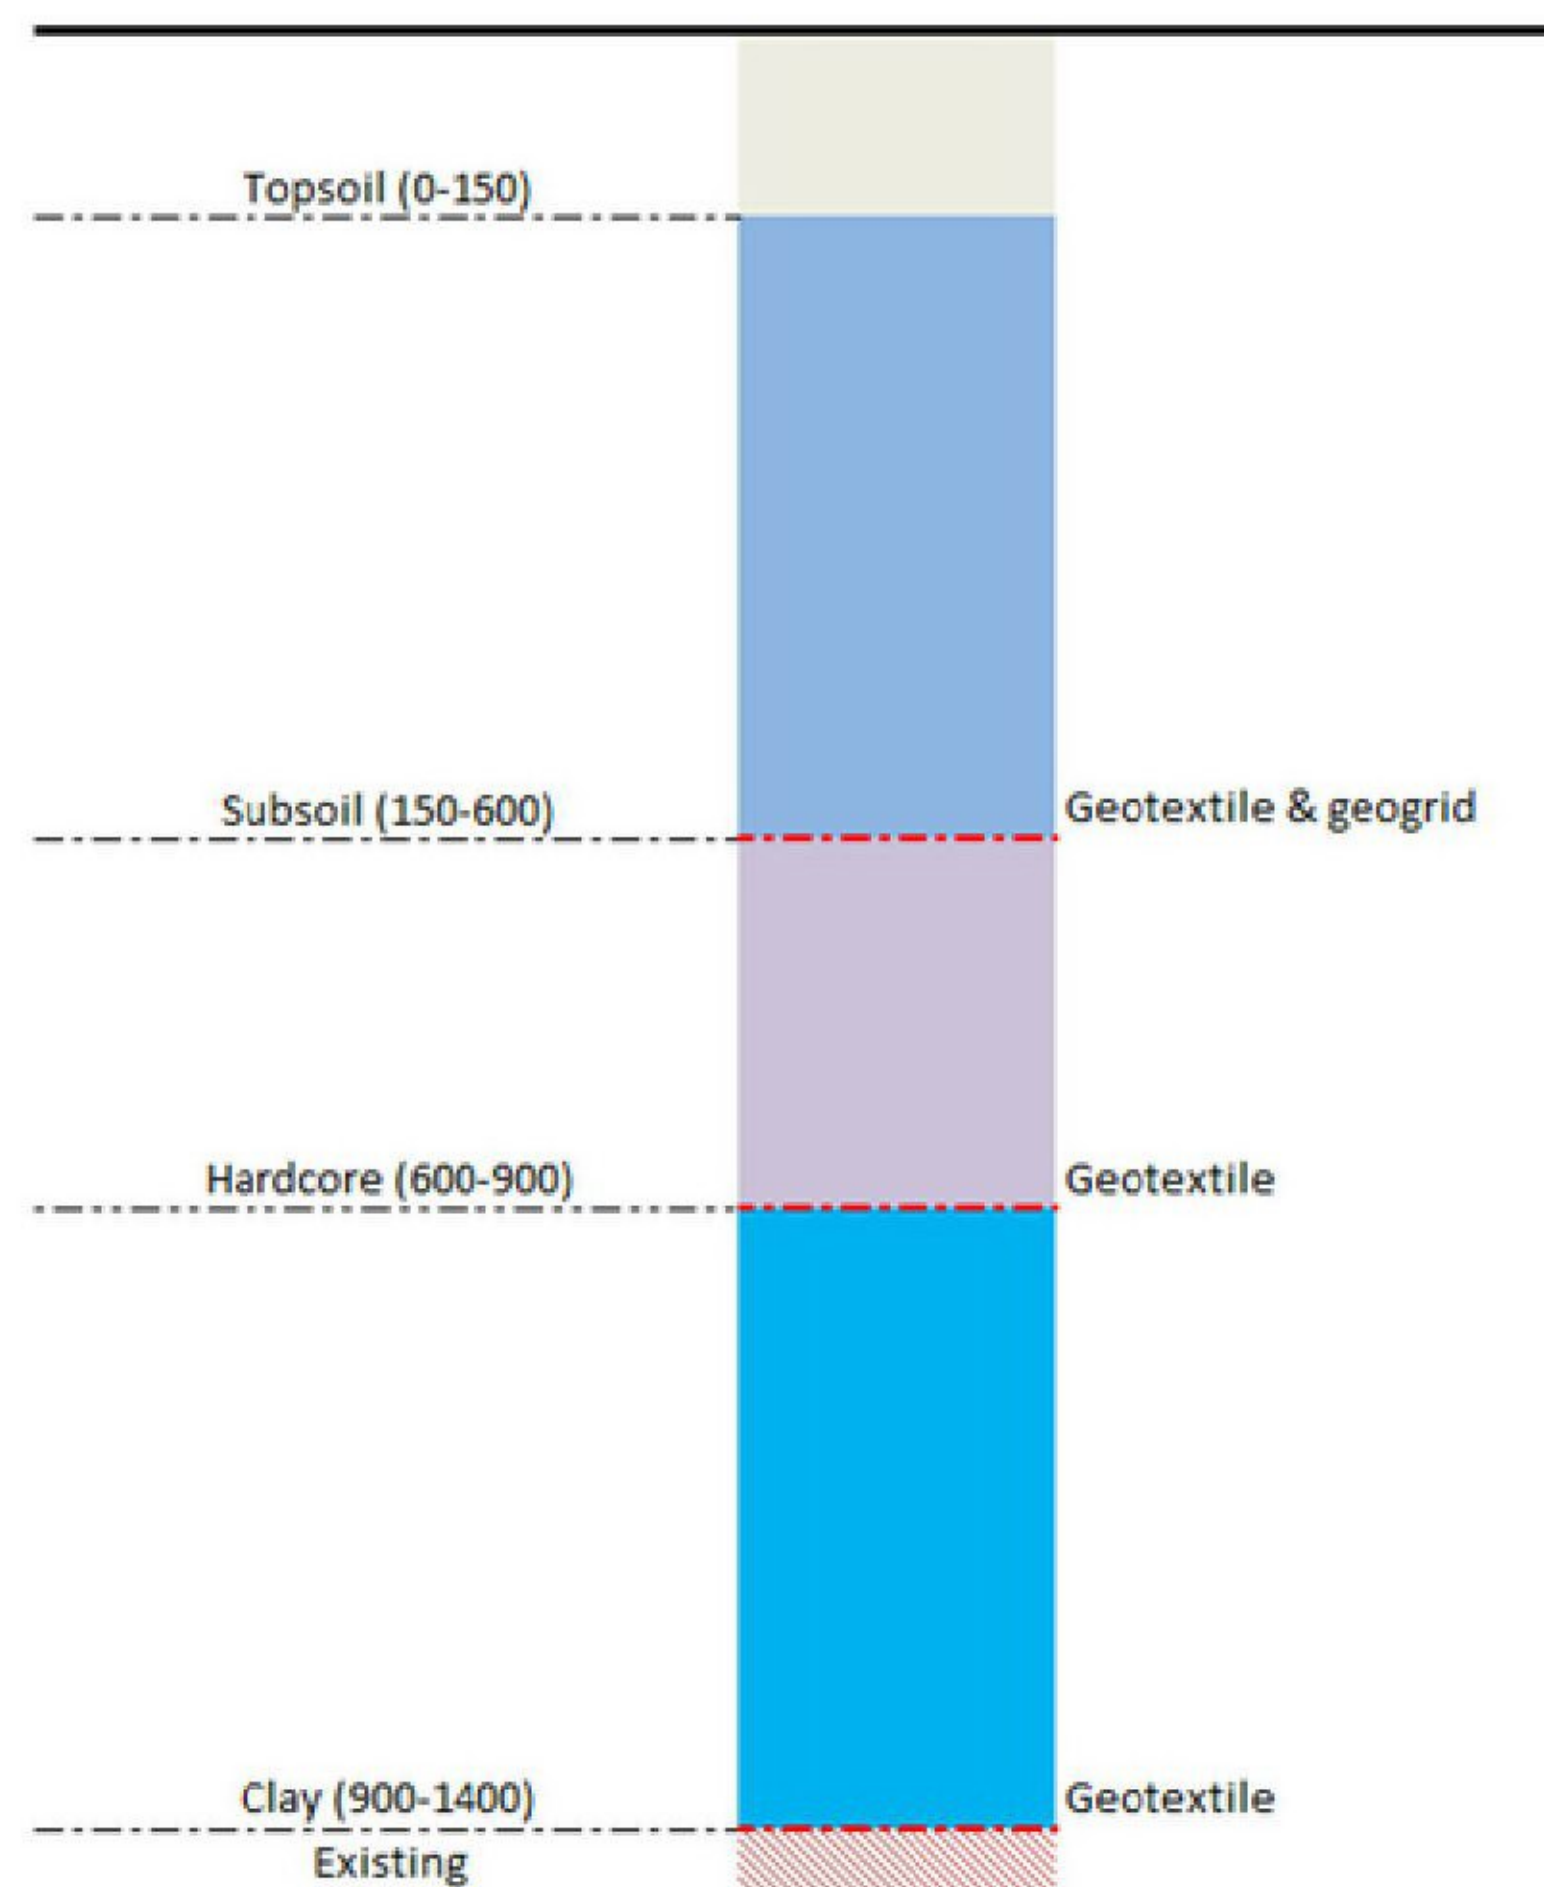
Figure 2 Proposed Cap Profile

The proposed cap comprises several layers of different materials (see Figure 2 below), including; clay, hardcore, subsoil, topsoil and geotextile membranes, and has been designed to form a low permeability barrier over the underlying waste materials and to help prevent plant roots and local wildlife from disturbing the underlying waste materials in order to maintain the long-term integrity of the cap. Once installed, the cap will lead to a site uplift in the order of 1.4m.

The site will be re-profiled before a cap is installed above the underlying waste materials. Significant excavations into the existing surface will be minimised to reduce the disturbance of the underlying waste materials.

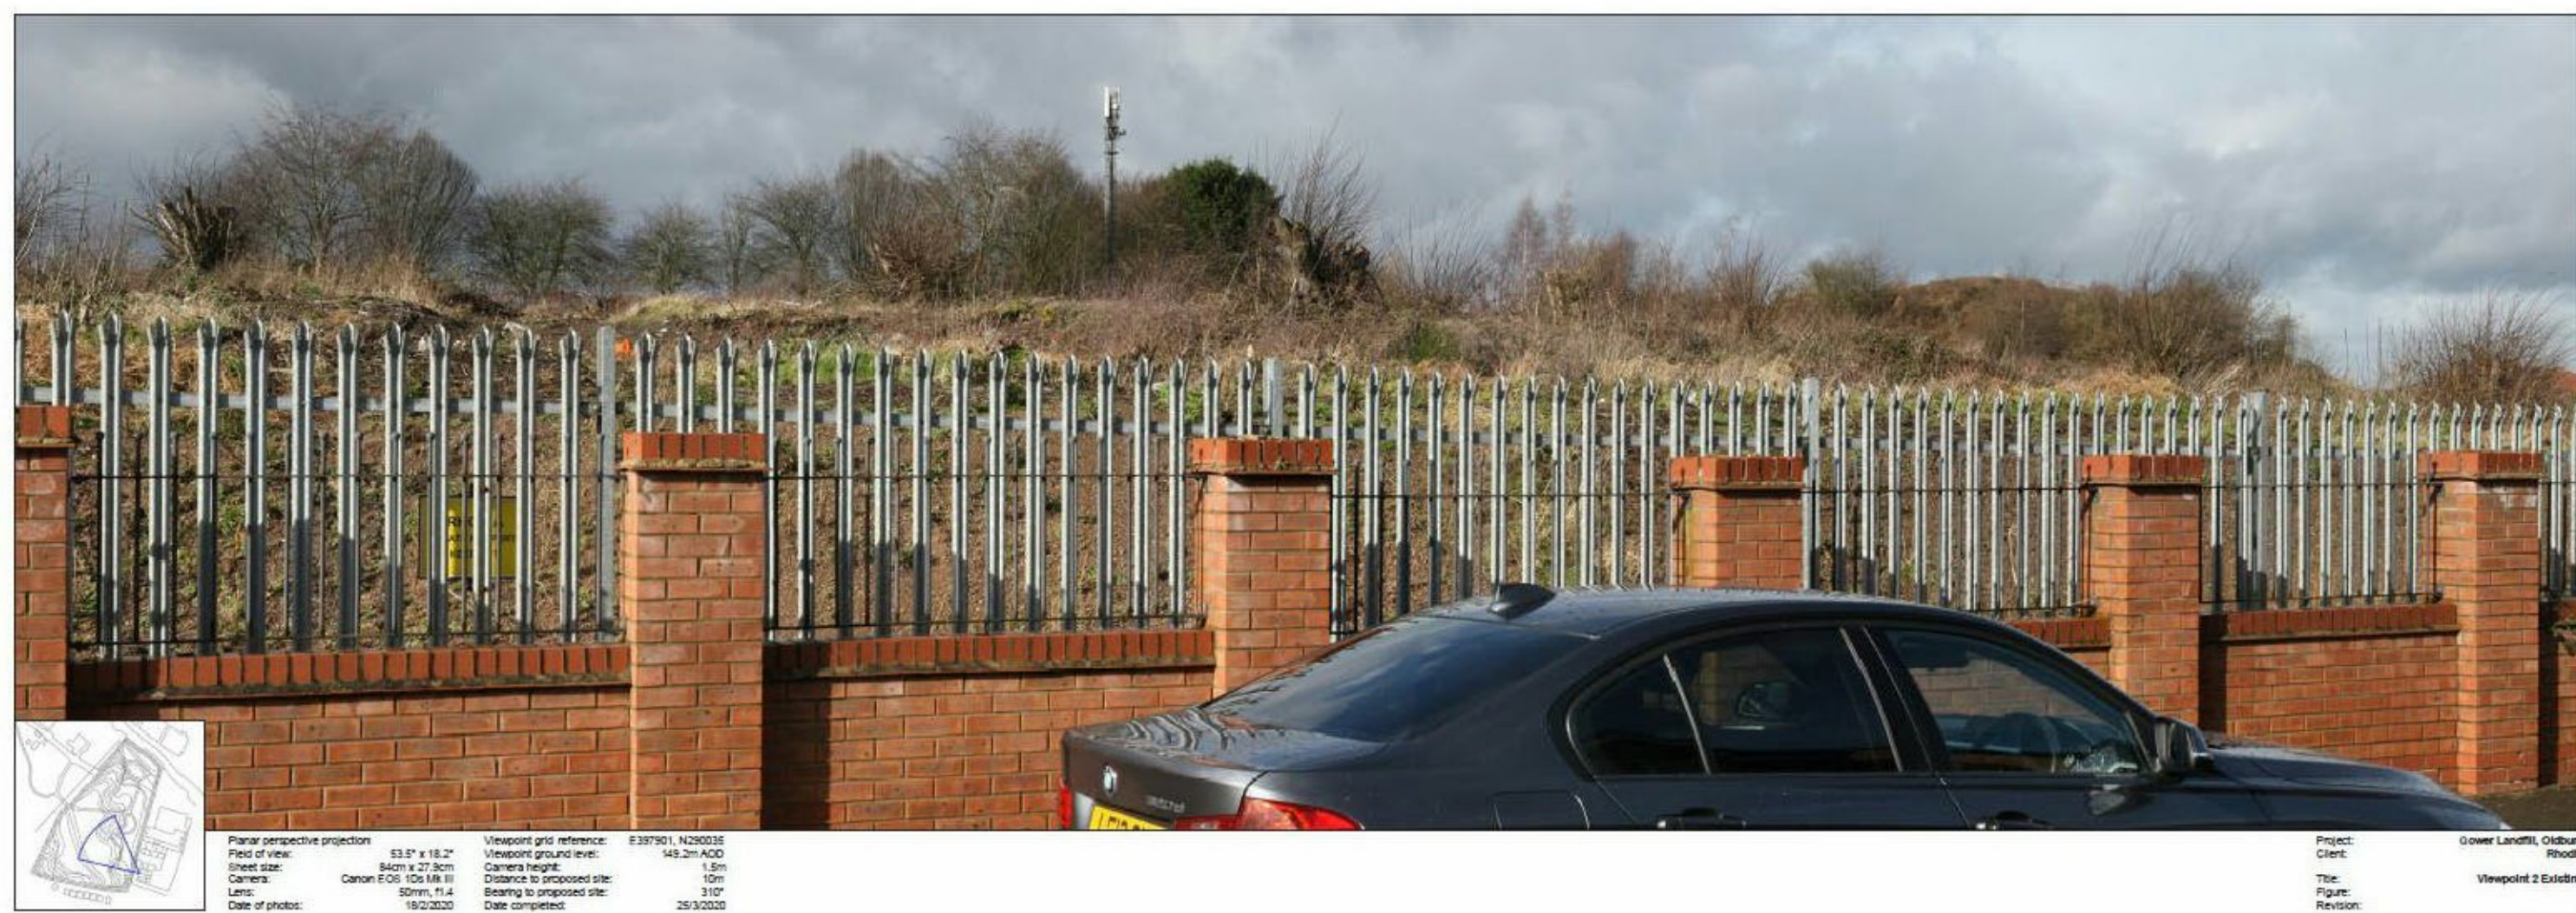
Figure 4 Existing View from George Wood Avenue (East of the Site)

The figures below present photomontages of the existing visual effect together with the predicted post remediation visual effects for years 1 and 12 from George Wood Avenue to the east of the site.
